Vagabonderende strømme

9. Juli 2020

Møde m. Energistyrelsen og Sikkerhedsstyrelsen
Landbrug & Fødevarer F.m.b.A. SEGES

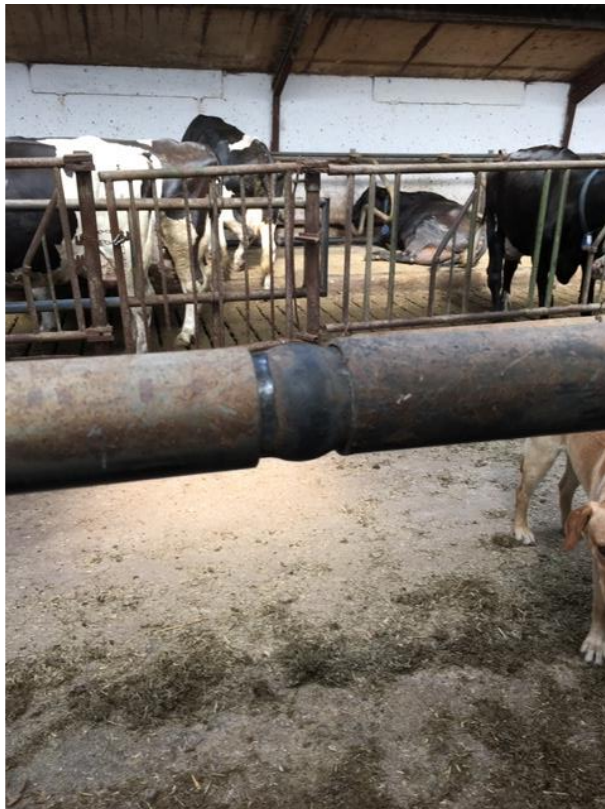
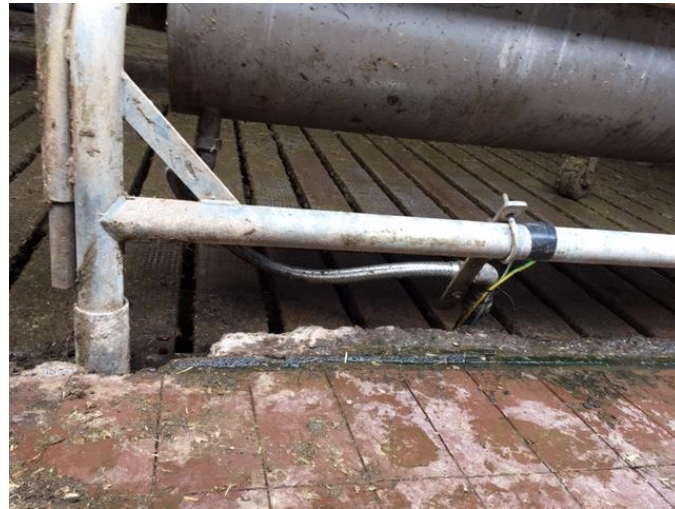
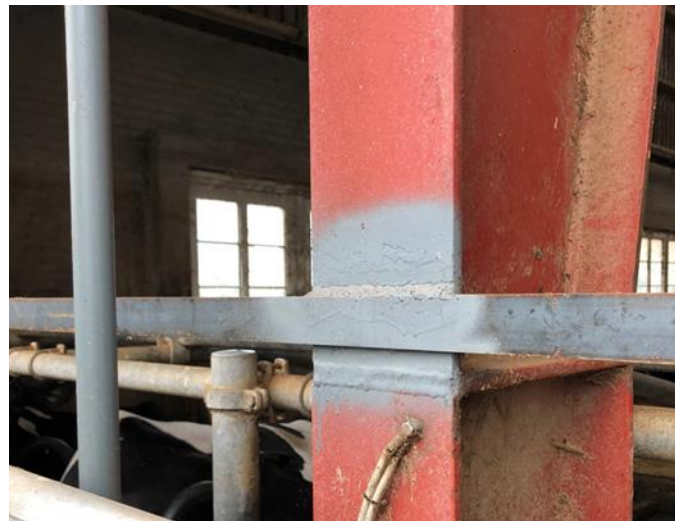
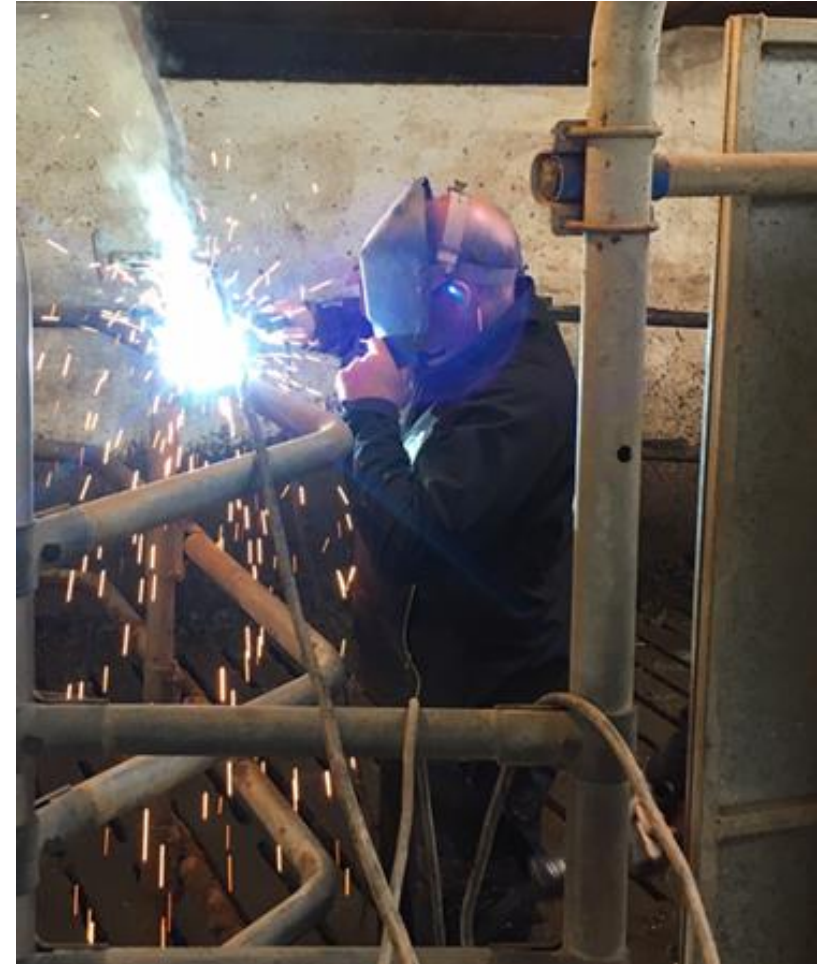
- Generel gennemgang af elektrisk anlæg
- Potentialeudligning
- Jordingsystem

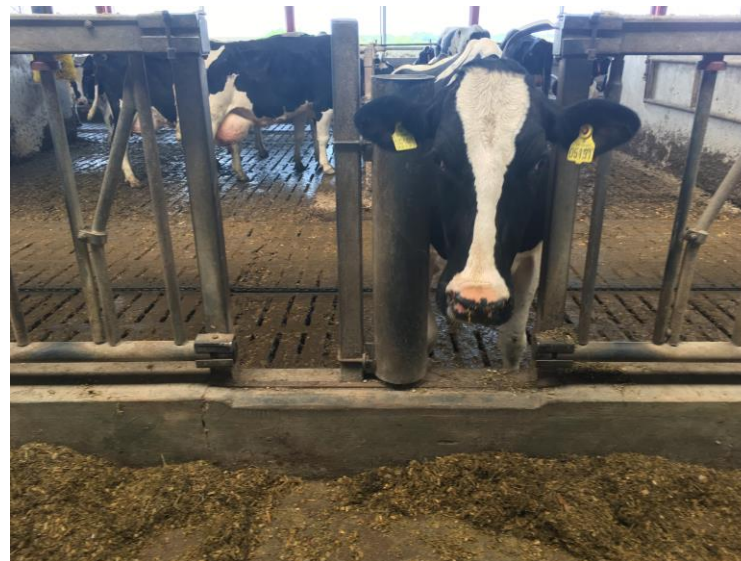
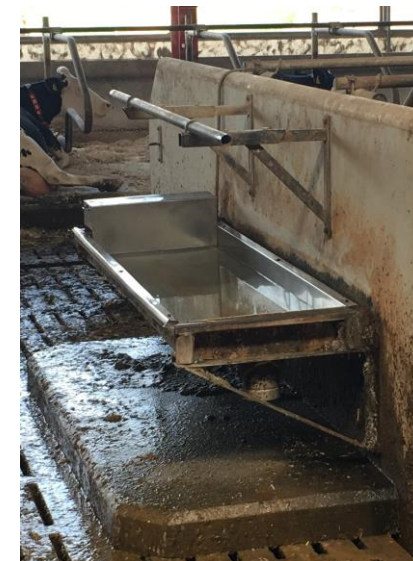
- Alternative løsninger forsøgt i aug. 2018
- Jesper Sørensen, Nørager el i sep. 2018
- Gennemgik anlæg – lækstømme fjernet fra bla. AMS, kobørster osv.
- Jording – specielt til AMS (25 kv. t.)
- Fladjern i hele staldens længde
- Drikkekar forsynet med udligning

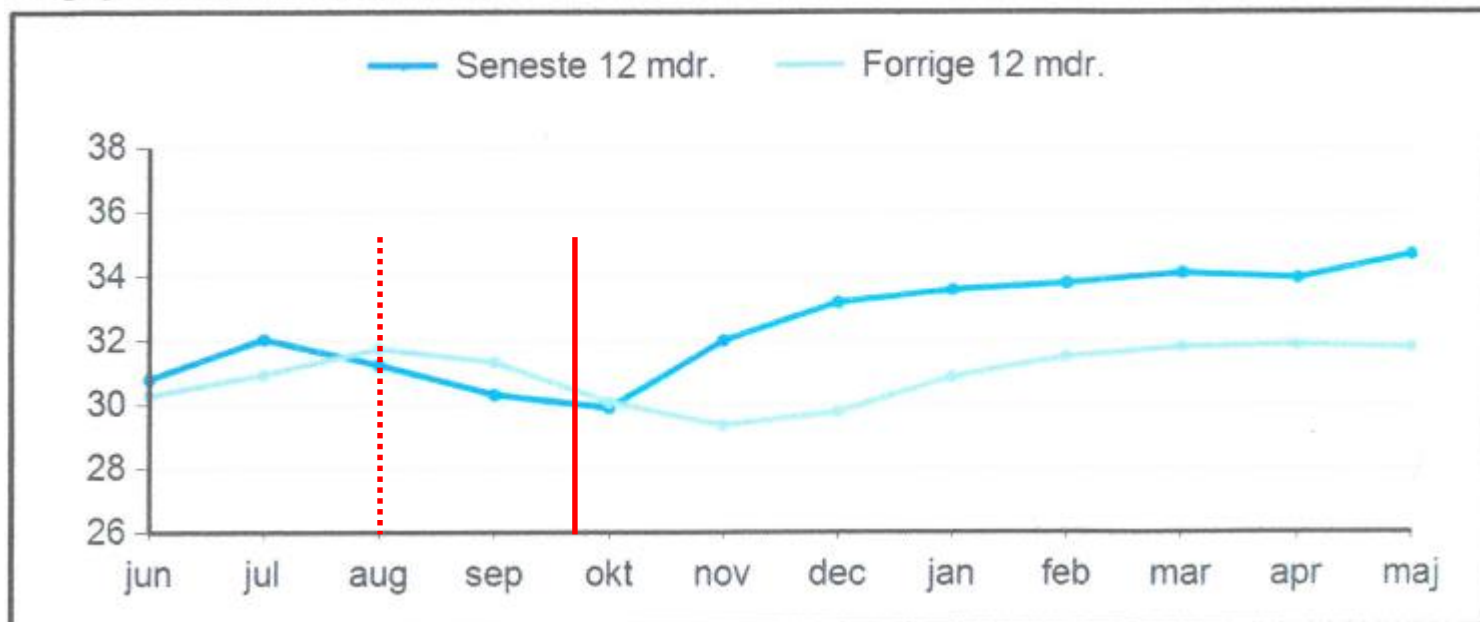
Dagsydelse pr. ko (kg EKM)

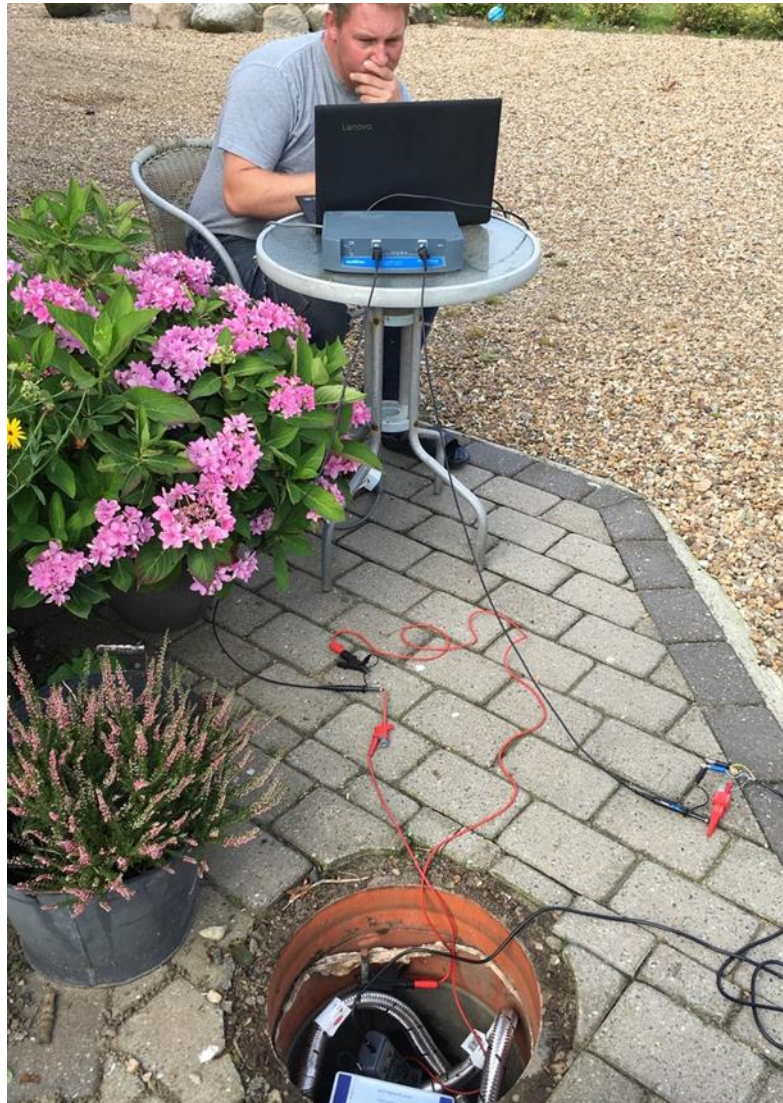
Spændingssignal for ejedommens vandrør og Byvandsrør

Esben Larsen DTU; Finder op til 10 v. på vandforsyningen

Jesper Sørensen, Nørgager el, måler her på vandindgang og finder en konstant frekvens på 31 MHz, og peak's på op til 4 v.

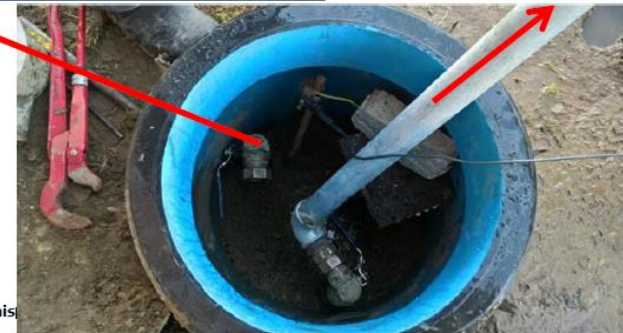
Indgang vandforsyning

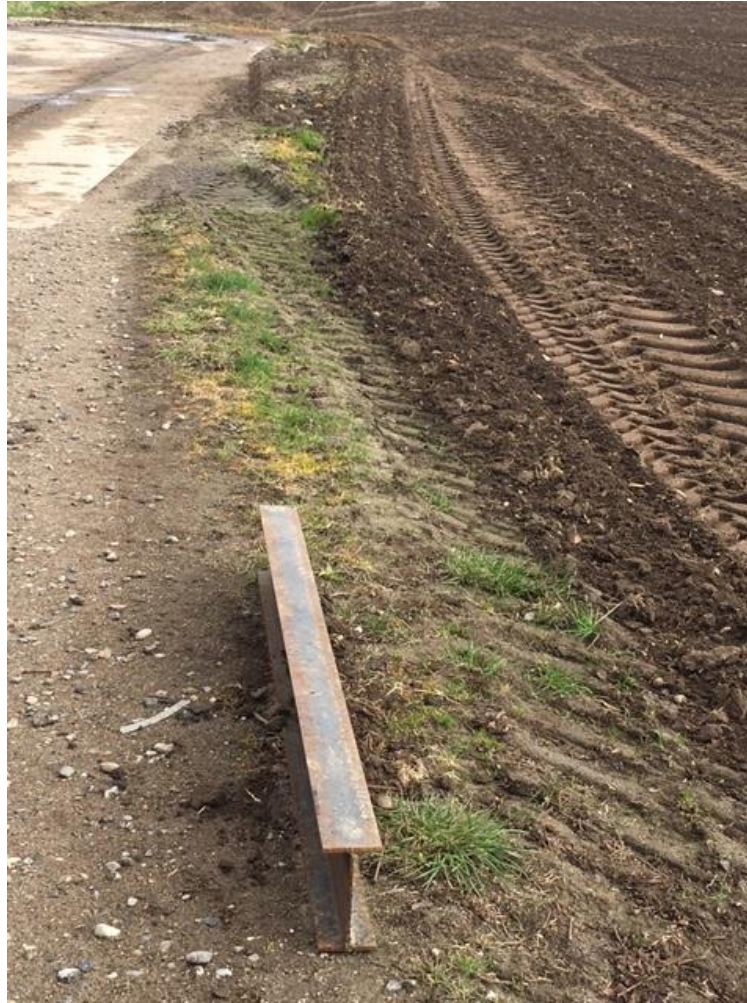
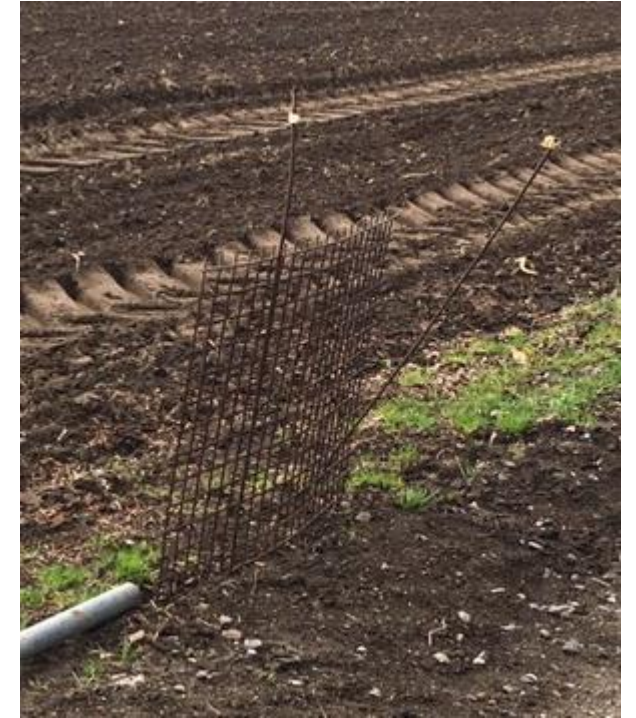
- Strømsstriber i jord – observeres kun med kobber og pendul
- Store gener for både dyr og mennesker
- Tidligere opsat potentialeudligning og jording er fjernet
