September 2019

## Validation of S1/S2 surface water detection

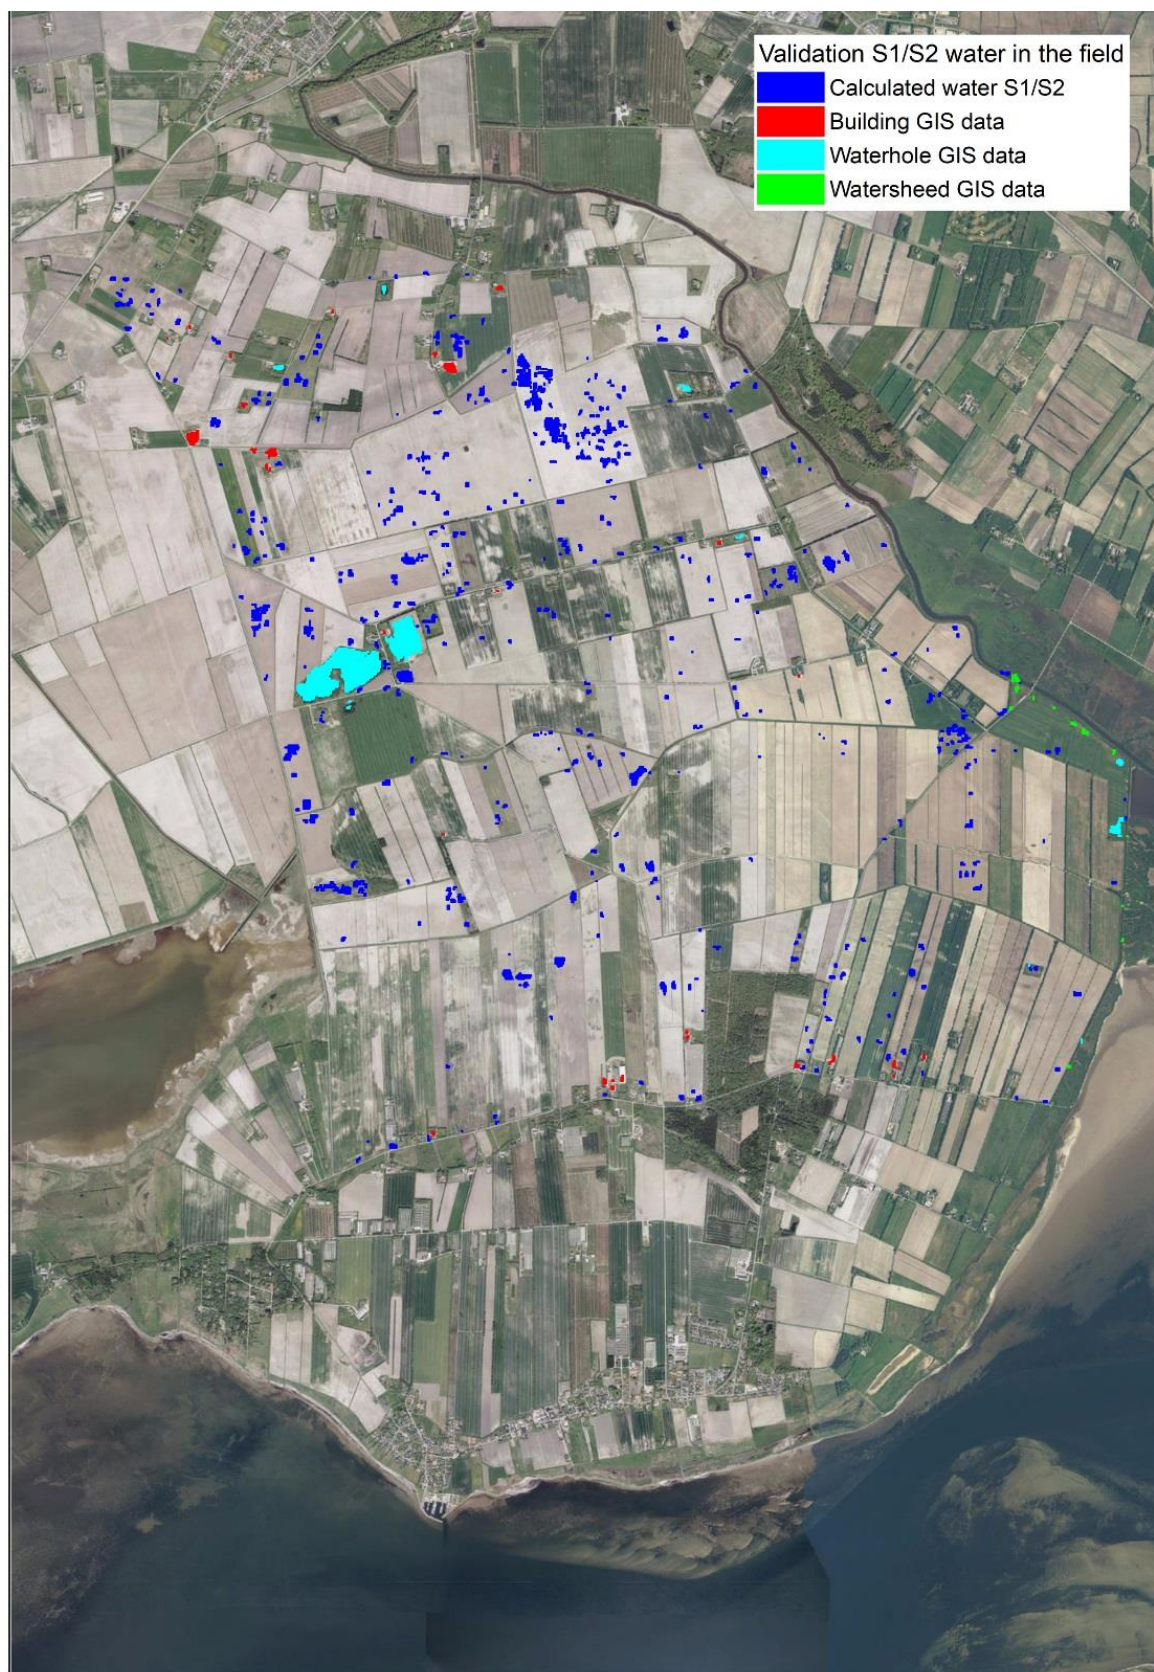
Figure 1: Location of buildings, waterholes and watersheds and calculated surface water areas.

First, based on existing GIS-data, buildings, lakes and other known water bodies were removed from the dataset. That was about 10 % of the total calculations (table 1). Figure 1 shows the locations of buildings and water bodies and water in the fields.

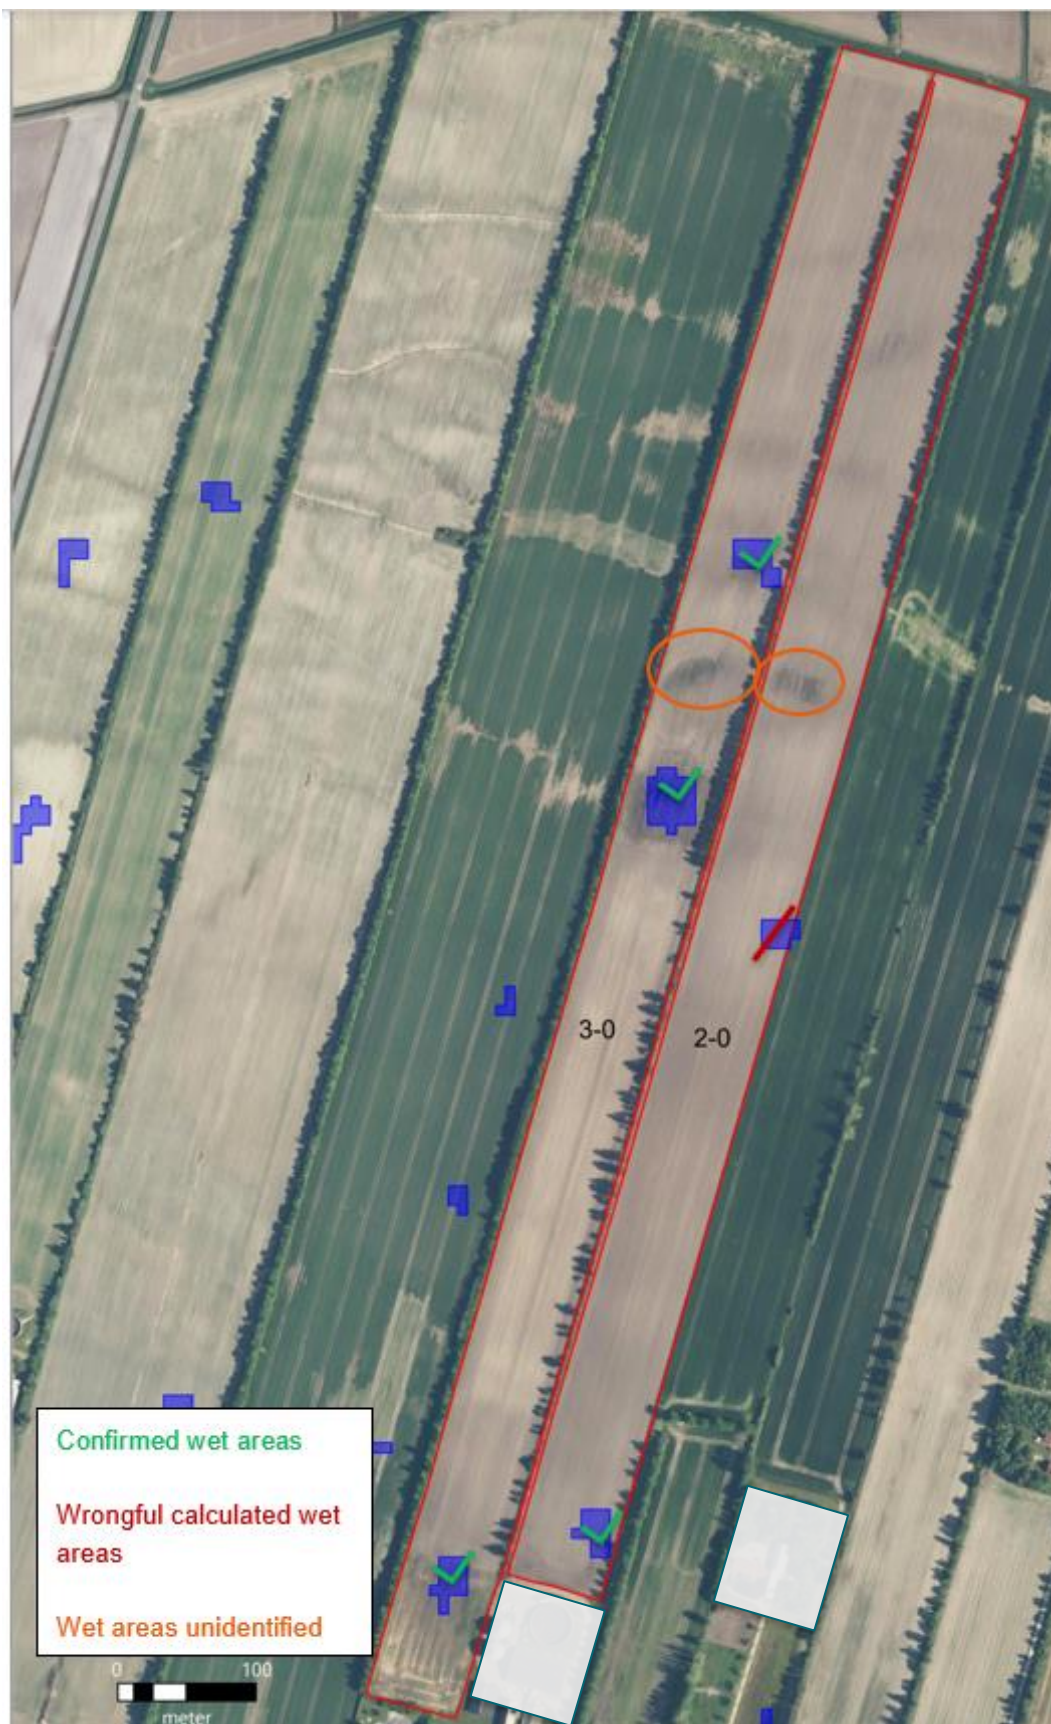
Figure 3: The orange circles mark the locations where the farmer has problems with surface water.

Three of the five farmers informed that the satellites failed to identify wet areas in their fields (for examples see figure 3 and 4). Areas that – to the farmers knowledge – were wet in March 2019.

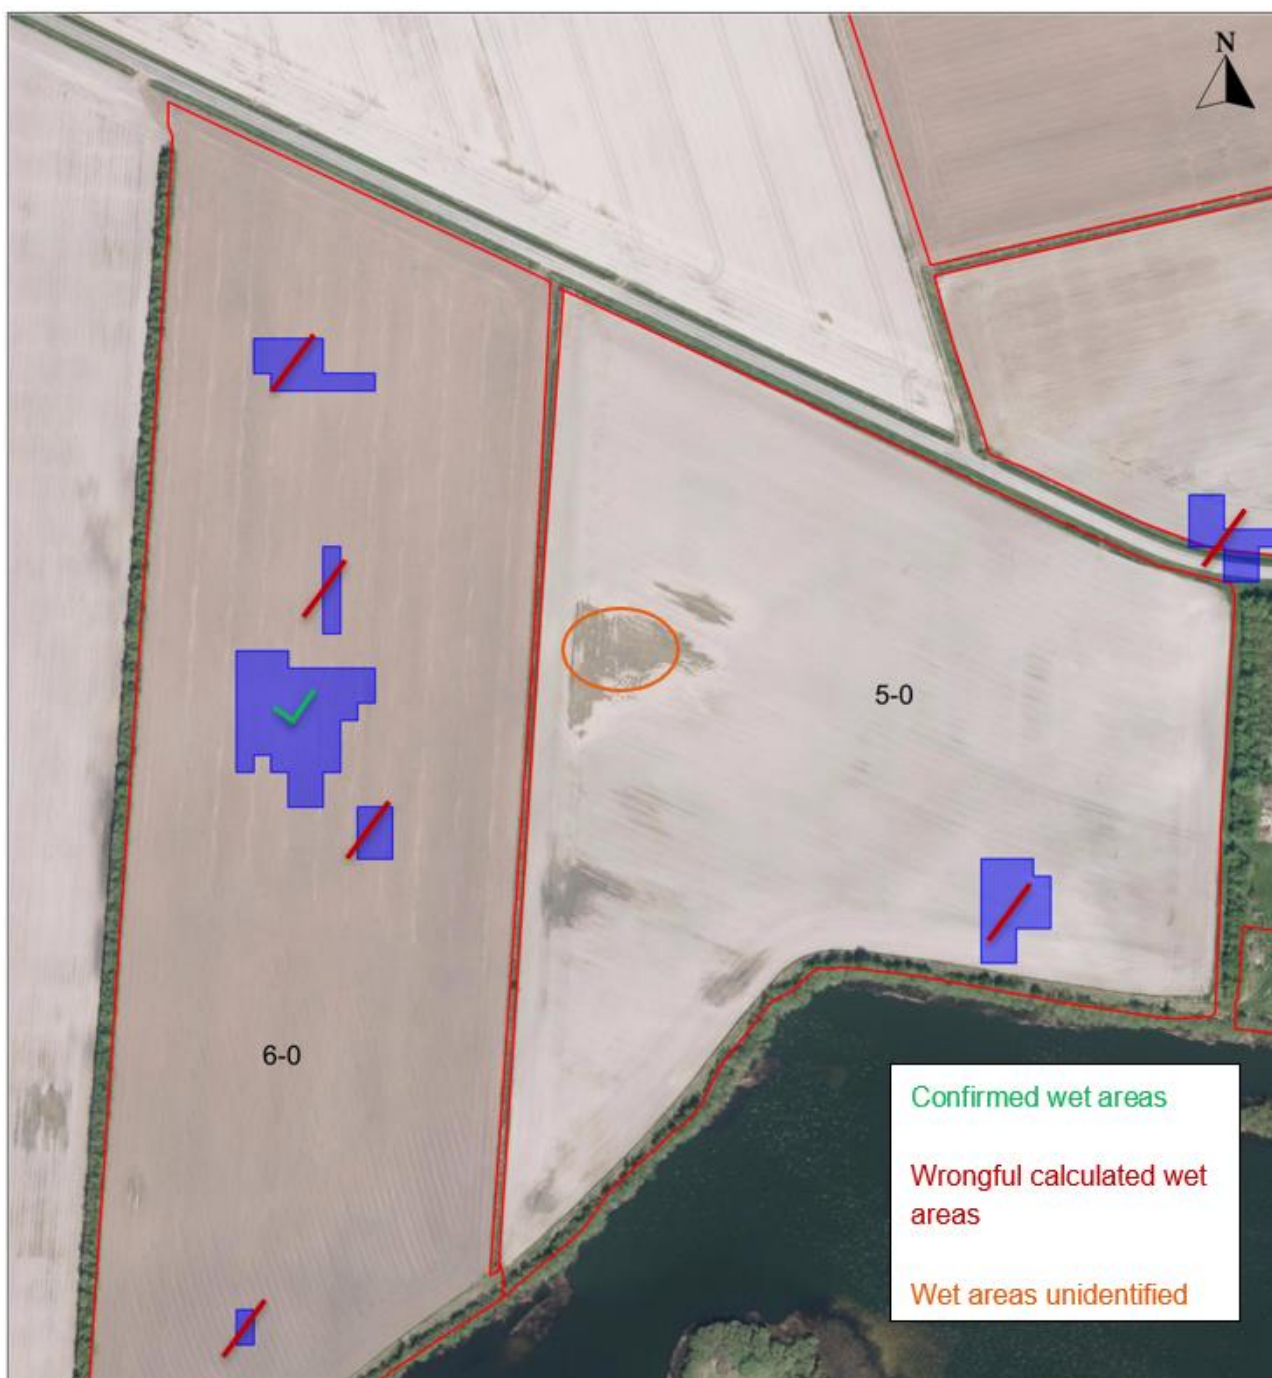
Figure 4: The orange circle marks the location where the farmer has problems with surface water.
