Vagabonderende strømme

9. Juli 2020

Møde m. Energistyrelsen og Sikkerhedsstyrelsen
Landbrug & Fødevarer F.m.b.A. SEGES

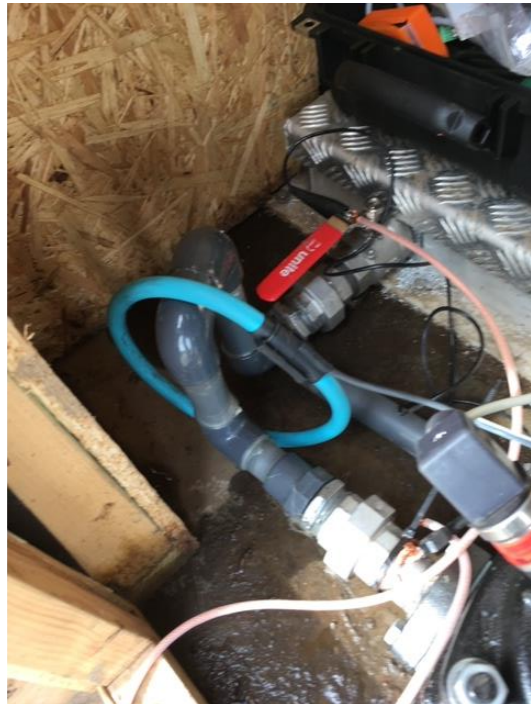
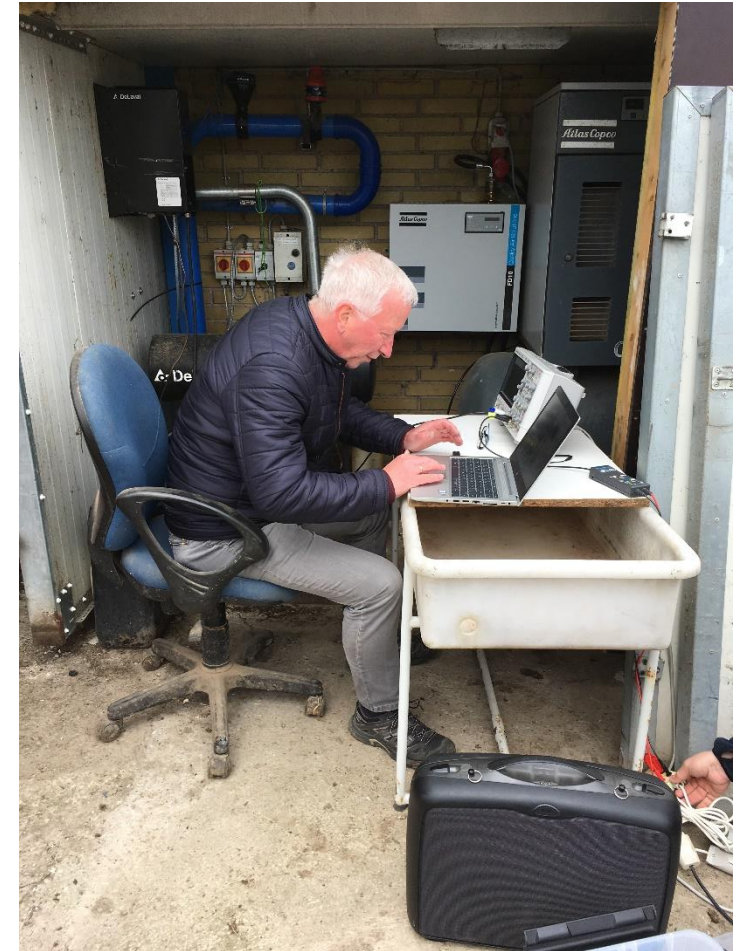
Strøm i Stald

- Generel gennemgang af elektrisk anlæg
- Potentialeudligning
- Jordingsystem

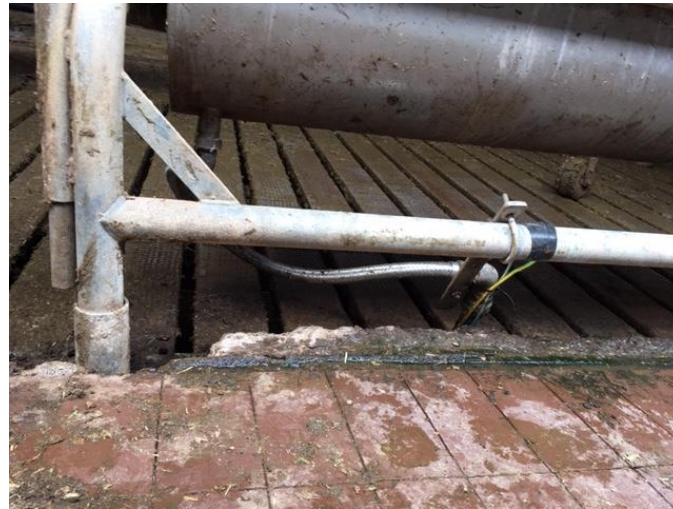
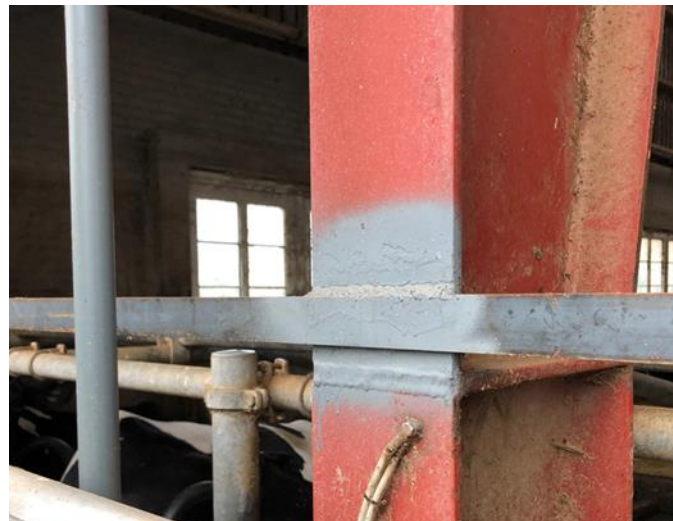
Strøm i Stald

- Generel gennemgang af elektrisk anlæg
- Potentialeudligning
- Jordingsystem

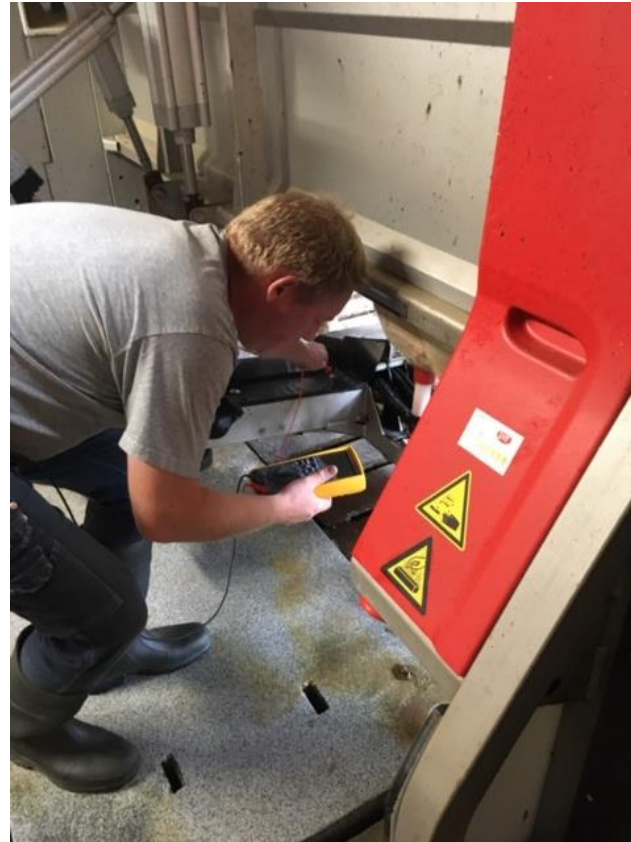
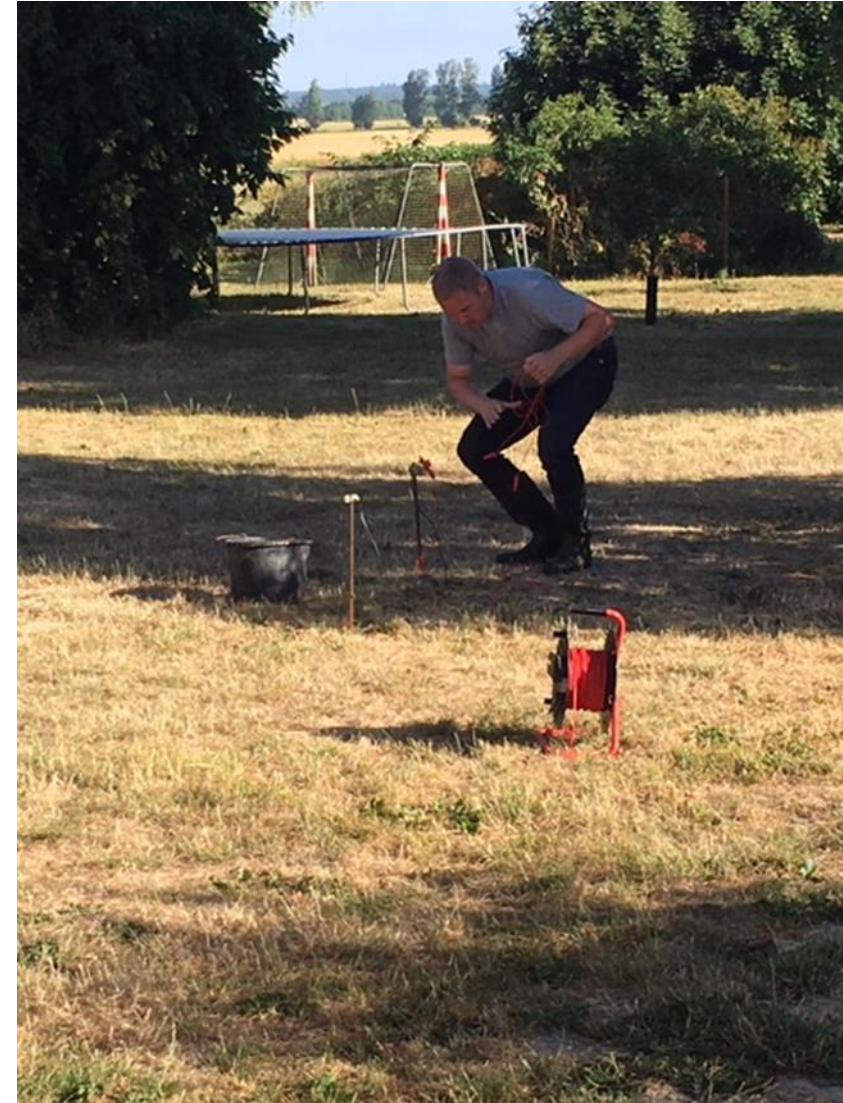
Strøm i Stald

- Generel gennemgang af elektrisk anlæg
- Potentialeudligning
- Jordingsystem

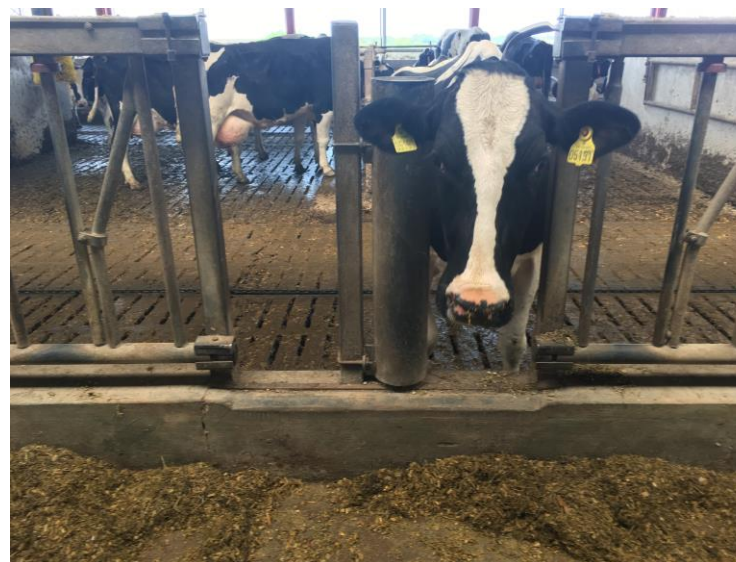
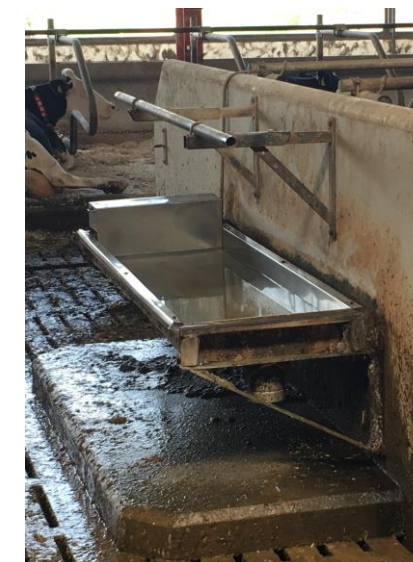
Løsning

- Alternative løsninger forsøgt i aug. 2018
- Jesper Sørensen, Nørager el i sep. 2018
- Gennemgik anlæg – lækstømme fjernet fra bla. AMS, kobørster osv.
- Jording – specielt til AMS (25 kv.)
- Fladjern i hele staldens længde
- Drikkekar forsynet med udligning

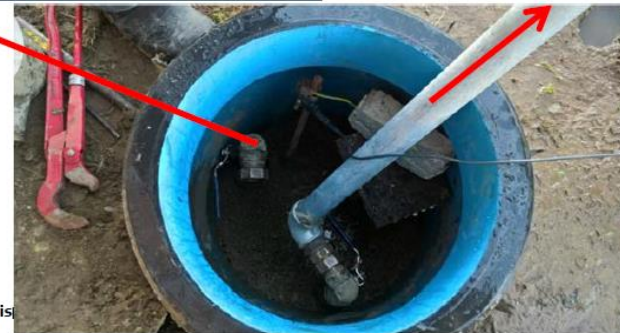
Indgang vandforsyning

Esben Larsen DTU; Finder op til 10 v. på vandforsyningen

Jesper Sørensen, Nørgager el, måler her på vandindgang og finder en konstant frekvens på 31 MHz, og peak's på op til 4 v.
