Samplig day 1-11-2021

Short update

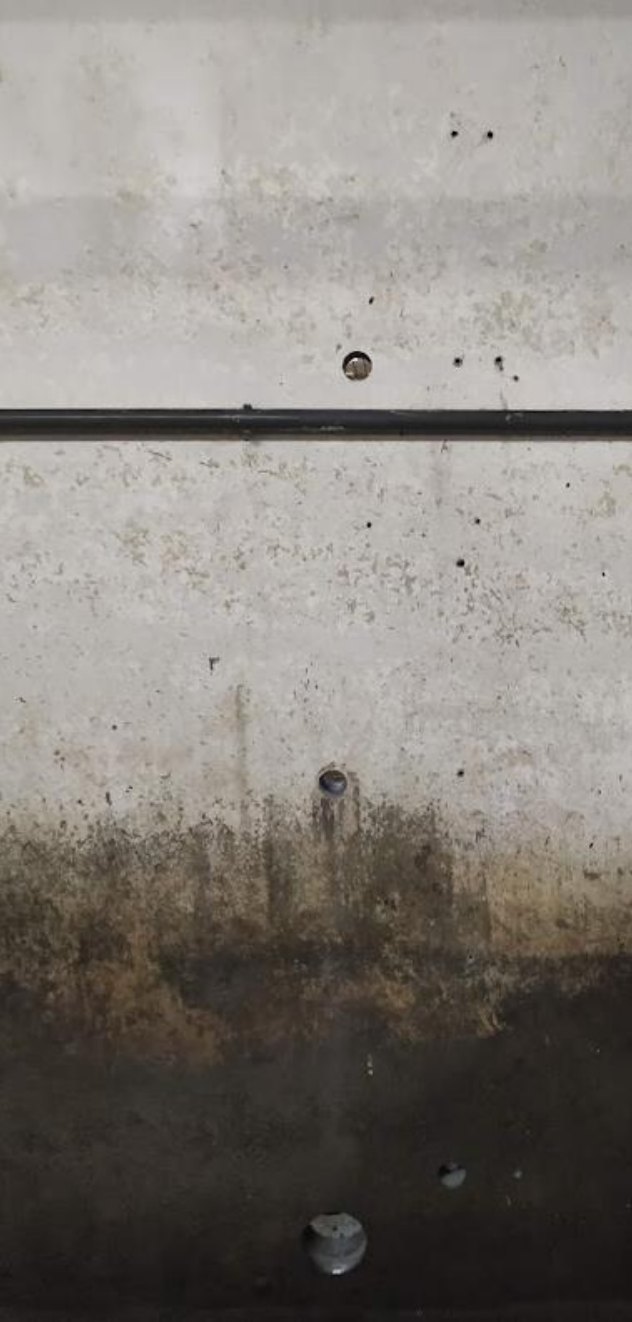
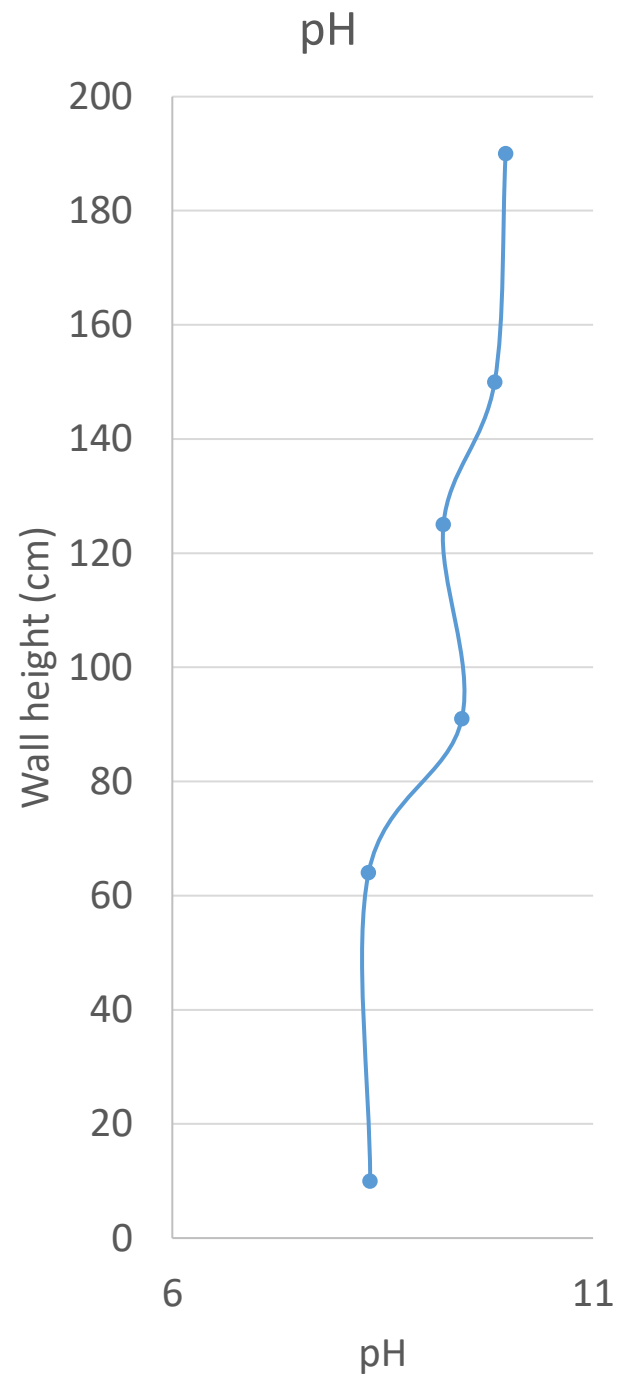
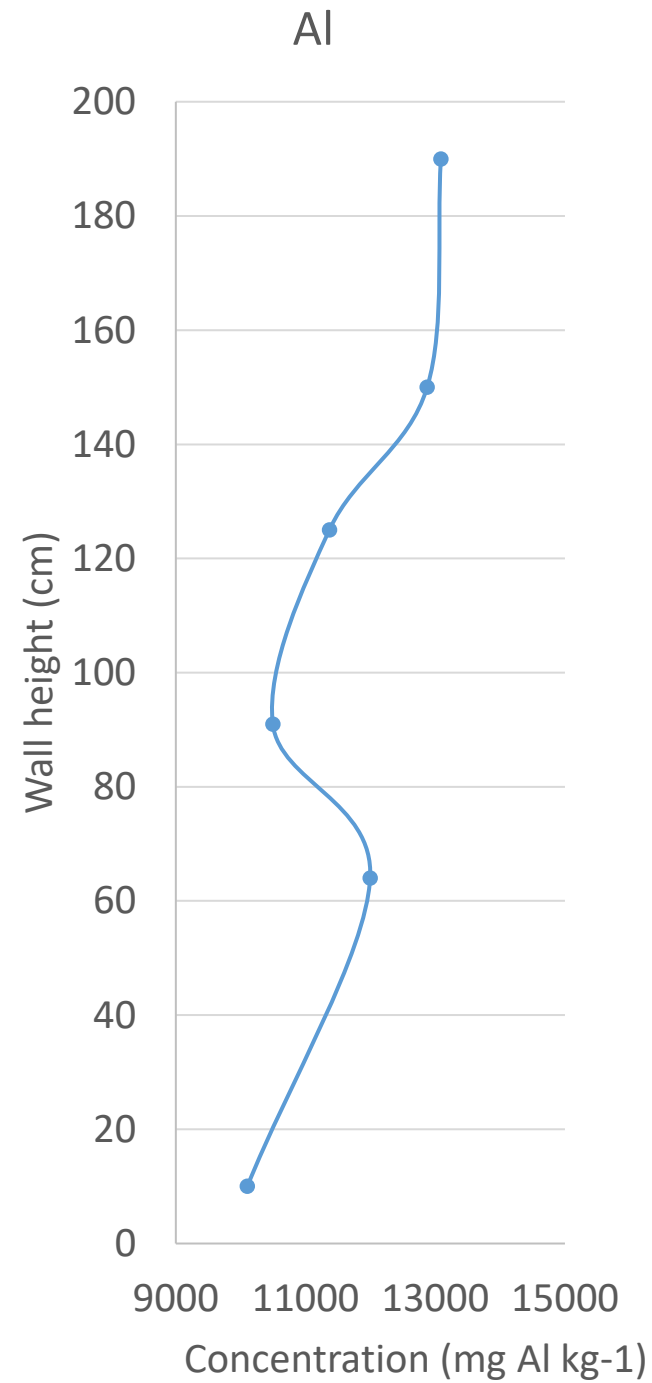
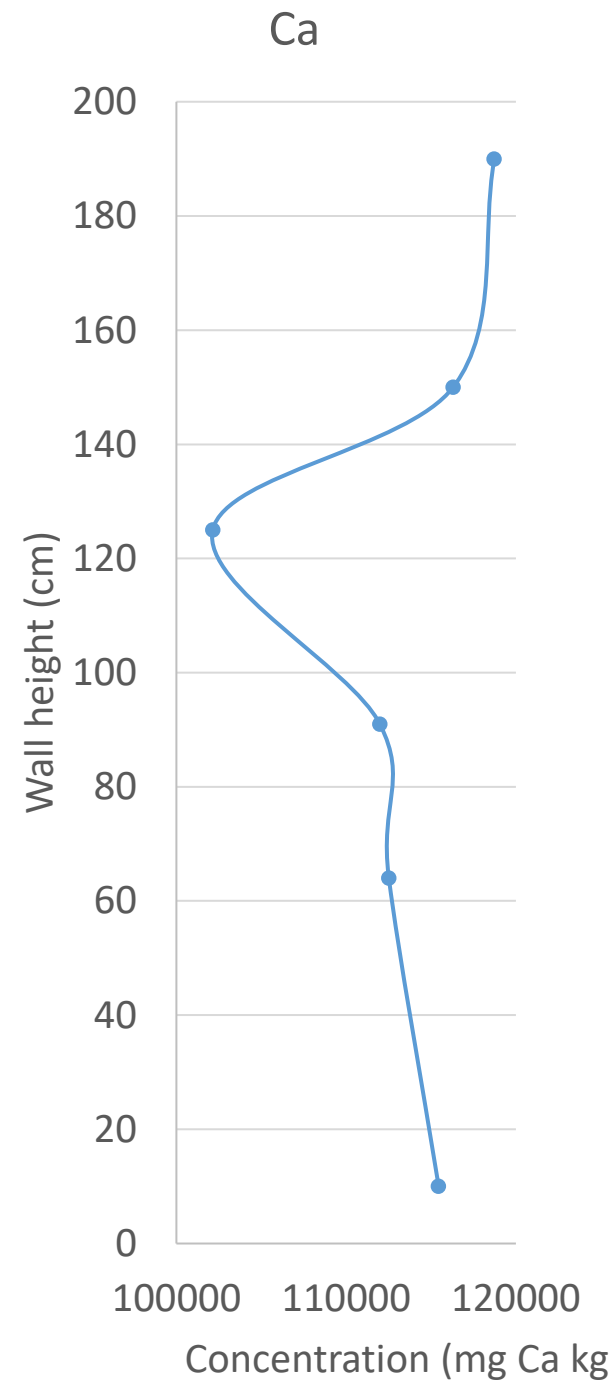
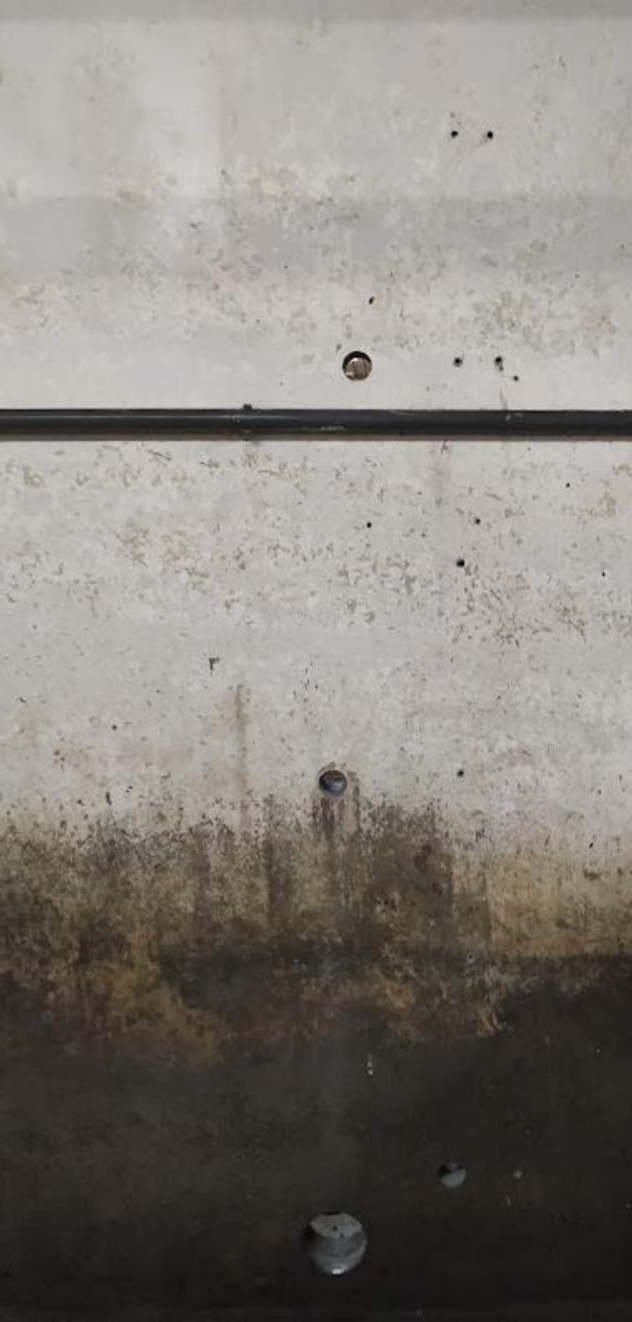
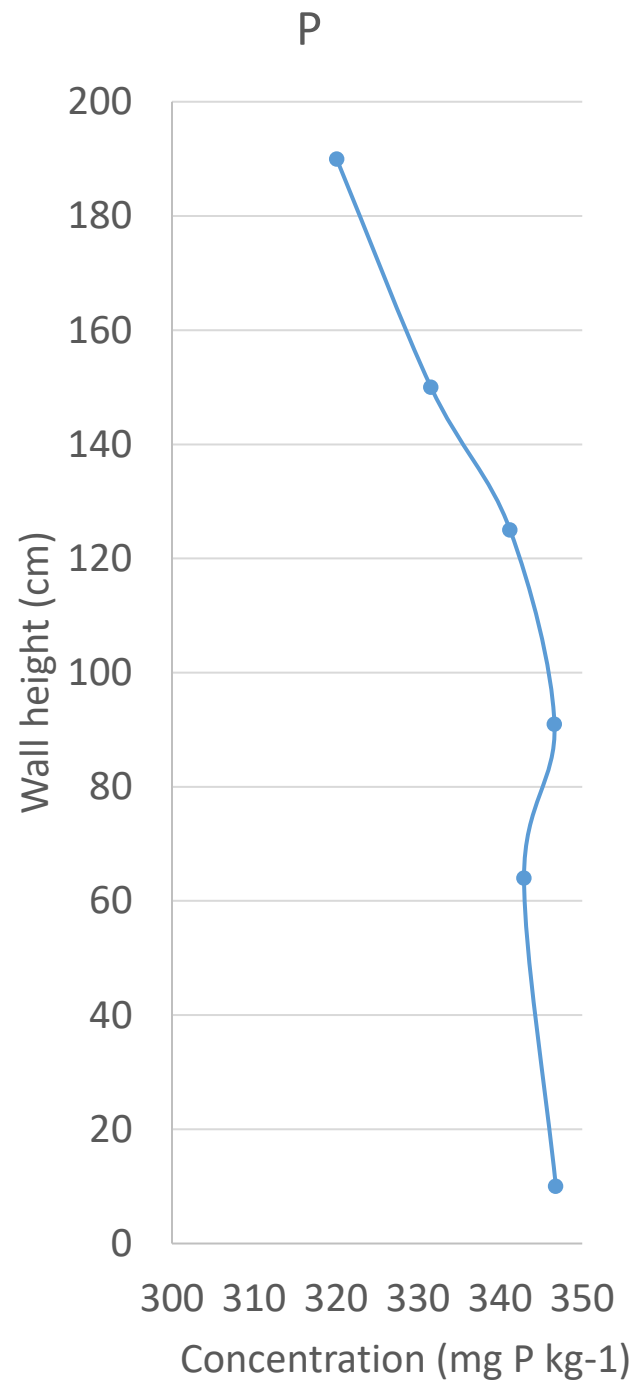
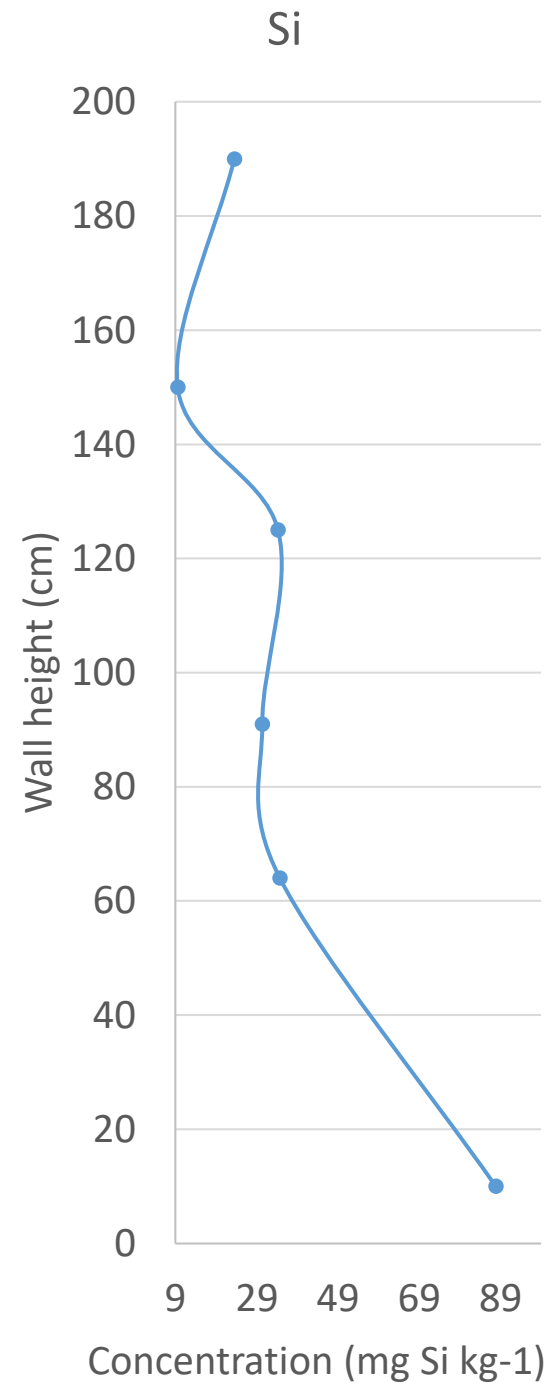
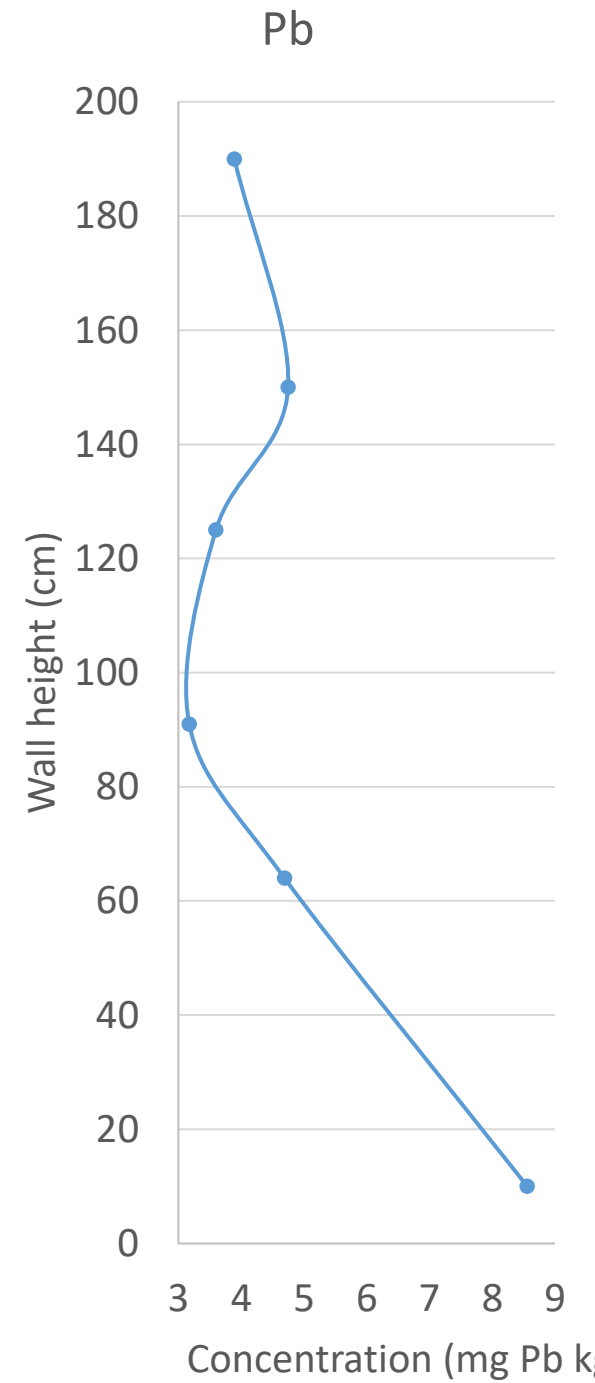
- NO nitrites or nitrites were found in the samples
 - Nor chloride or sulfates
 - N in pig manure is normally in the form of urea ($\text{CO}(\text{NH}_2)_2$), that quickly decomposes into ammonia (NH_3)
- We need to investigate where we can quantify ammonia contents, because our IC only identifies nitrites or nitrites
- The following are total concentrations in the concrete

- Scenario 1
 - Look into other 30+ year old pigfarms
 - Compare strength, ions and ammonia along the wall height
 - Suggest recommendations to increase concrete durability
- Scenario 2
 - Effect of age on concrete performance (10, 20, and 30+ years of use)
 - Compare strength, ions and ammonia along the wall height
 - Recommend time restrictions on the usage of concrete in pigfarms
- Requisites:
 - All the concrete studied needs to be in the same conditions (inside walls)
 - We need a reference sample – unexposed to pigfarm leachate
